Manhole Inspection Summary

Manhole # S41AA_050MH

Insp Date: **8/5/08 3:08 PM**

Location Address: **rear 741 n central**

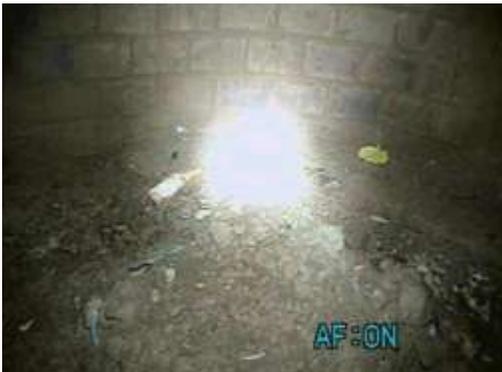
Defect 3

Condition: Sound Cracked Root Intrusion Deteriorated Leaks **Debris**

channel debris

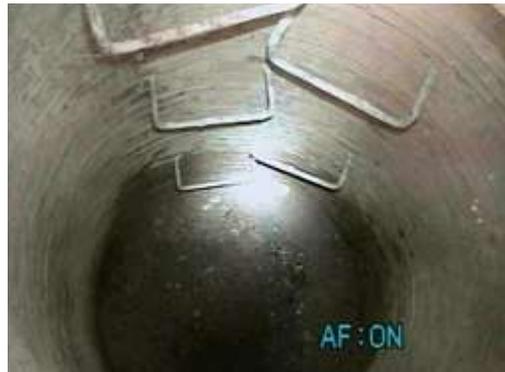
Defect 2

Steps Count: **5** Missing: **0** **Corroded**

Surcharge **Evidence Of Surcharge** Depth: **2** (ft.) Active Surcharge Present

corroded steps, surcharge evidence

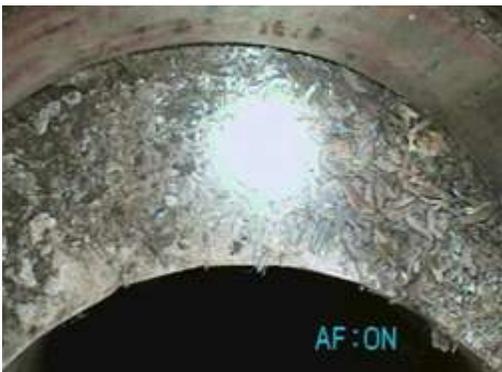
Defect 1

Frame Offset: **9** (in.) Condition: Sound Cracked Leaks

offset

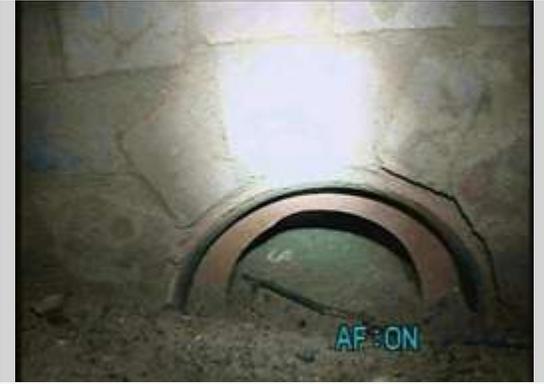
12 O'Clock Outflow

8 in. Circular Gravity Sewer
Pipe Out @ 12 O'Clock

Deposits: None Mud Sludge **Debris** Grease

Silt Depth: **0** (in.) Deposits Extent: **Medium**
